# Gimme A Brake

## TSB SAVES THE DAY WITH TRICKY FORD PICK-UP REPAIR

documents represent recognized problems that have been identified and more importantly the correct remedy. Ford issued a TSB on 1995 F-250 and F350 Light Trucks. The bulletin number is 98-5A-34 and the issuing date is 3/18/1998. Its title is “High Brake Pedal Travel or Low Brake Pedal Feel”. The problem addressed is described as – “The brake pedal may feel low or there may be long brake pedal travel on some vehicles. This may be due to the master cylinder bore size”.

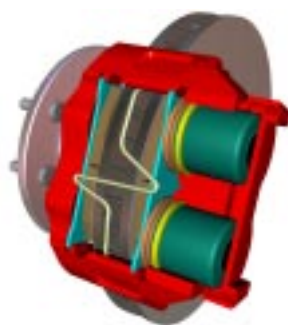
Figure 1

to apply the disc brake pads. Under ideal circumstances the master cylinder provides just enough fluid to move the caliper pistons to apply the front brakes. Over time the caliper tolerances change due to wear and the master cylinder no longer can provide the necessary volume without added pedal travel. The end result is excessive pedal travel, which is often described as a “pedal that goes to the floor”.

To understand what's going on we must first think about the brake system used on these trucks. These vehicles use dual piston floating calipers (Figure 1). Dual piston calipers require a large volume of fluid to move the caliper pistons in order

Assuming the front brake inspection does not provide the cause of the problem, proceed with the master cylinder replacement. Use the chart in Figure 2 to determine the

part number. The master cylinders listed have larger bores than the original equipment unit. They will provide the necessary volume to work the dual piston calipers in an acceptable amount of pedal travel. Make sure to use the correct application.
